FACILITY ASSESSMENT
LAKE OF THE WOODS SCHOOL
BAUDETTE, MINNESOTA

NOVEMBER 2023

WIDSETH

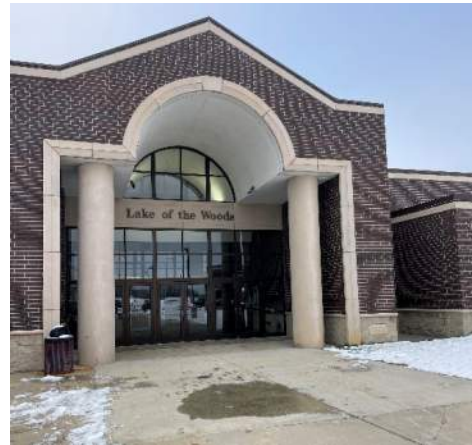
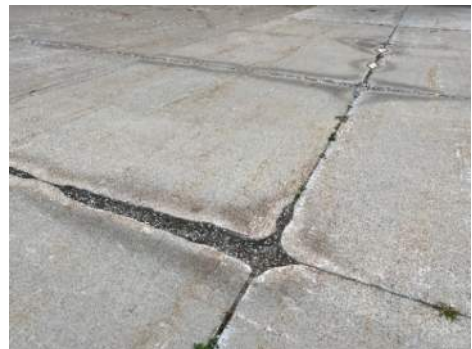
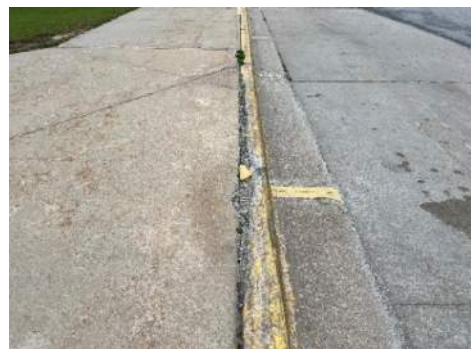
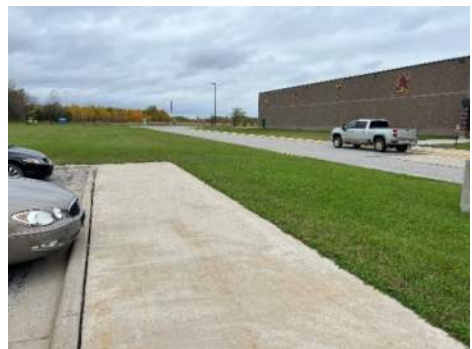
The sidewalks constructed as part of the original construction and subsequent additions are showing significant deterioration due to their age. The primary issue consistent through most areas is cracking of the concrete along control joints leading to depressions which grow in size and depth due to annual freeze-thaw cycles. Such conditions can also be exacerbated by the use of salts during winter months. In addition, freeze-thaw cycles have created uneven panels which result in trip hazards. At the main entrance area there are low spots which collect water. When these areas freeze they do create a significant safety issue. Injuries have occurred as a result of this condition. The existing layouts are generally consistent with accessibility requirements and should be maintained and improved on with any future work.

The pick-up and drop-off areas on the north and east sides of the facility only include sidewalks leading directly from the entrances to the road. This can become very restrictive during winter months leading to students having to walk on the drive lane and creating a safety hazard, or vehicles backing up until they reach a sidewalk causing a congestion issue.

There are also opportunities to add additional sidewalks around the site to improve accessibility to all areas. Sidewalk access can be improved between the parking lot and the ice arena entrances. Currently, the shortest path would require an individual to cross turf. Sidewalks should also be provided between the parking lot and throughout the athletic complex for spectators.

Recommendations: It is recommended that all sidewalks be replaced with new. In areas where the curb and gutter adjacent to the sidewalk has also deteriorated, that should be replaced as well. At the drop-off/pick-up lane on the north side of the building, a sidewalk should be added that runs parallel, alongside the drive lane. In addition, there are opportunities to add an additional sidewalk leading from the parking lot to the ice arena.

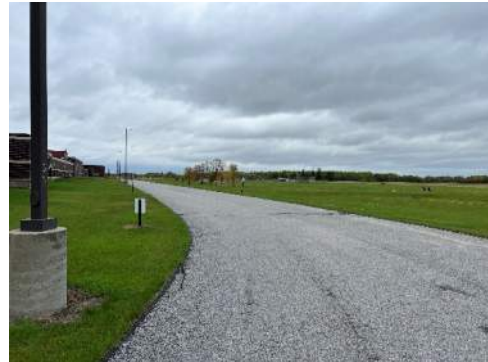
The drive lane on the north side of the facility currently serves as the parent drop-off and pick-up areas for the building. This area was not initially designed for this type of use. Walkways lead directly from the building exits to the drive lane. There is no sidewalk running parallel to the drive lane. This creates challenges for directing pedestrians during winter months. As a result, there are significant safety issues created with students entering and exiting vehicles and potentially crossing drive lanes.

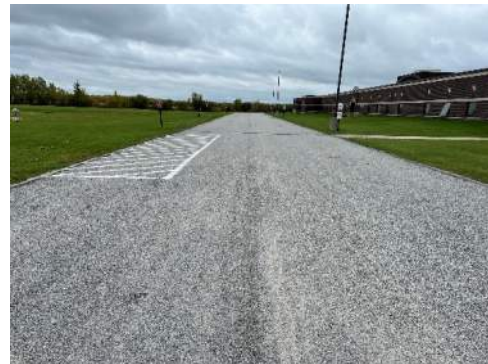
On the south side of the facility, there is an existing loop that runs in front of the building that serves as the bus lane. South of this lane is the primary parking lot for students, staff, and visitors. In addition, there is another small parking lot located to the southeast. The primary issue is the crossing of traffic between the three areas at the entrance to the bus lane. When leaving the small parking lot, you must cross the drive lane as buses enter the bus lane.

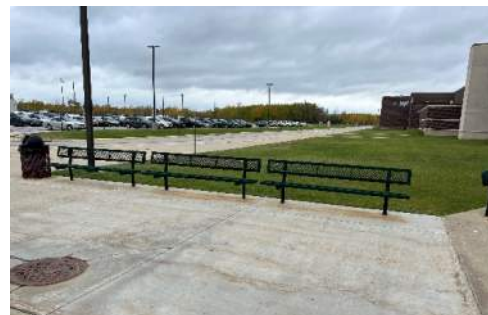
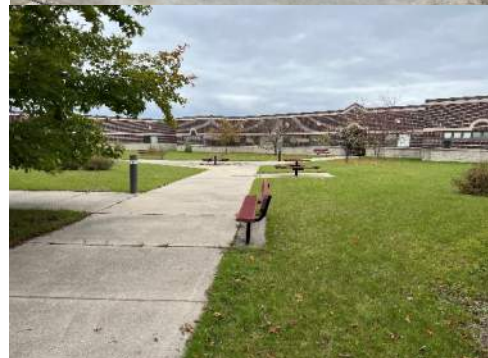
Lake of the Woods School has a combination of benches, picnic tables, bicycle racks, and waster receptacles. Currently, these are located at the main entrance area and within the courtyard area. All site equipment is in fair to poor condition. Most are showing their age with color fading, cracked paint, and rusting. Some benches are in worse condition due to vandalism and/or damage due to snow clearing. The primary challenge with most of the equipment is that they can not be removed.

Recommendation: Replace existing site equipment with new to include benches, picnic tables, bicycle racks and waste receptacles. It is also recommended that waste receptacles be provided at all entrances and areas where students and visitors are expected to gather or enter the building. Any new site equipment

provided should have the ability to be easily relocated to allow for easier snow clearing operations.

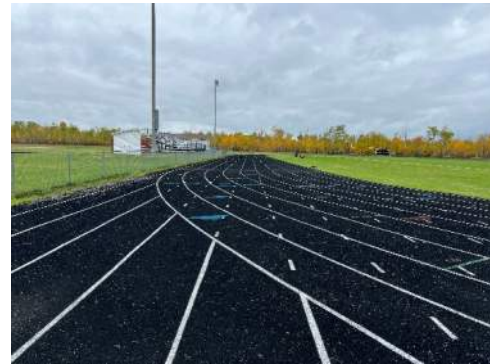
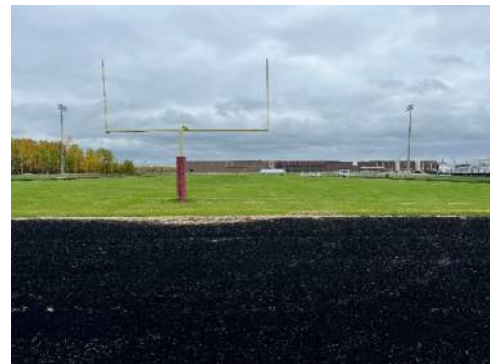
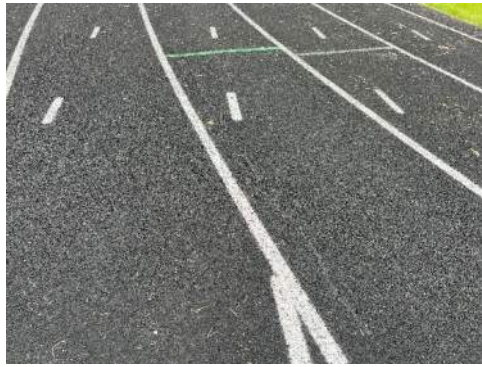
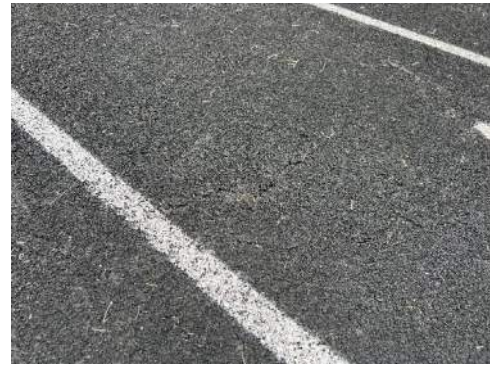
The existing football field, running track, and support athletic spaces were constructed as part of the original building project. The football field currently lacks an irrigation system, thus requiring staff to use time to set up, move, and remove sprinklers. The football field turf area also requires regarding to provide level playing surface with positive drainage to the perimeter. The existing perimeter lighting consists of halogen fixtures.

The existing running track is showing significant signs of it's age. The current running surface and dips and low spots from settling, minor heaves, and cracking of the surface. The cracking allows moisture into the track system leading to further degradation. Finally, the uneven surface leads to potential challenges from holding track events.

Support athletic spaces to the running track include a pole vaulting area, long jump, shot put, and discus areas. All areas are in poor condition and should be refurbished.

Recommendation: Replace the existing running track with a new surface. Regrade the existing football field and install an irrigation system for greater control. Install new perimeter event lighting. Refurbish existing support athletic spaces.

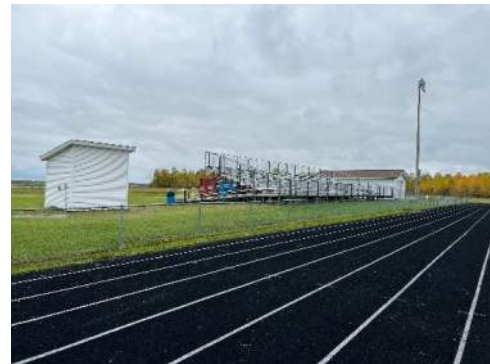
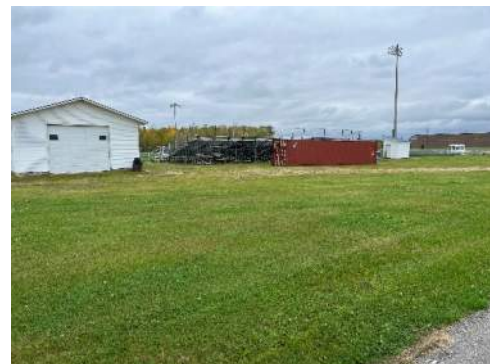
The support spaces for events occurring at the athletic complex are limited. They consist primarily of two storage buildings on the southeast side of the complex and a press box building on the northwest side. Accessibility is limited.

Recommendations: To improve the amenities available to spectators, it is recommended that a single building be constructed on the backside of the bleachers that would include concessions, accessible restrooms, and storage space for equipment. The upper level of the building could also include a press box. For estimating purposes, it is assumed the building would have a footprint of approximately 900 sq. ft. This allows for a minimum of 6 fixtures within each restroom, concession stand, and storage space. Sidewalks should be provided between the bleachers, support spaces, and parking lot.

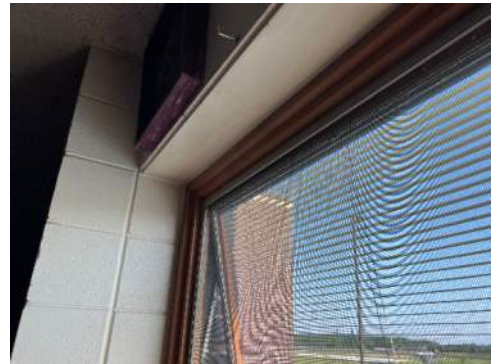
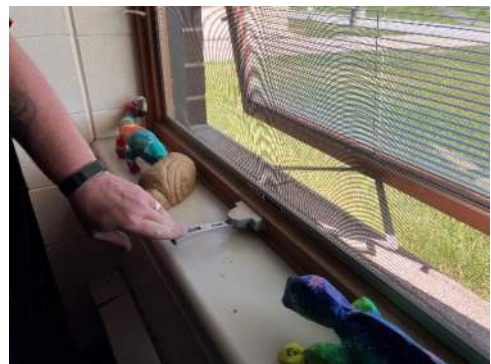
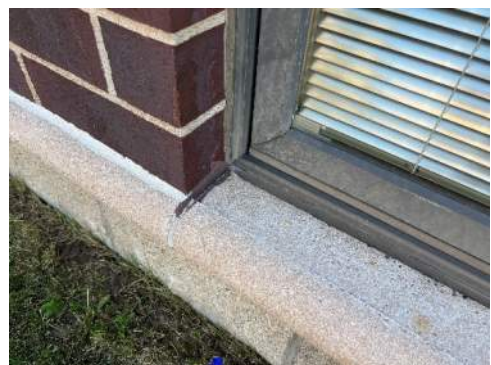
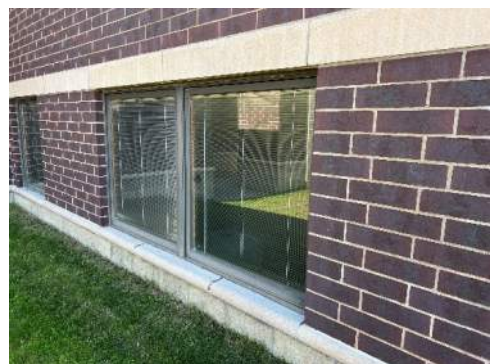
All the original metal-clad exterior windows in the school need replacement due to worn or inoperative hardware, sun weathering, deformation due to structural movement, or rotting from being repeatedly frozen while wet. The windows are Pella Clad Stationary and Awning assemblies of varying sizes and were installed in 1992 when the school was built. The awning windows, which open from the bottom outwards, are referred to as operating windows. Windows which do not open by design are referred to as stationary windows.

With a few exceptions which are newly replaced units, the stationary and operating windows are metal-exterior clad wood windows, made up in Removable Double Glazed configuration. All the original windows have lattice-type mini-blinds hung between the panes. The interior glass panes remove by pulling small hinged catches which engage slots in the stiles. The blinds operate by turning a small knob at the lower right corner of the interior screen which engages a small gear box to pull supporting strings up or down.

The operation windows along the east facing walls show the greatest degradation due to weathering and structural movement with about half either stuck shut or unable to be closed completely without outside applied pressure. The south window in Room F139 (Ms Krause) is stuck shut due to deformation of the outside wall which appears to have heaved up from frost and jammed the so; against the sash.

Windows along the south facing walls show increased degradation due to sunlight with plastic hardware parts having become brittle and broken. Windows along the north wall show increased degradation due to inclement weather and frost, with wood sash bottom rails rotting. The between panel blinds work in about half the units, and after 31 years, repairs parts are no longer available. Of the 131 operating windows inspected, 83 were deemed to operate satisfactorily.

Recommendation: It is recommended that all aluminum clad wood windows be replaced with a similar style window system. Separate window blinds should be installed at openings to provide sun control, but also allow for future replacement if they break.

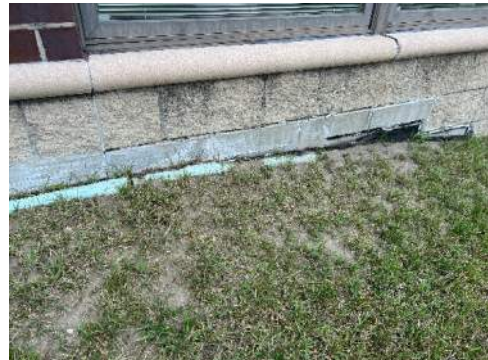
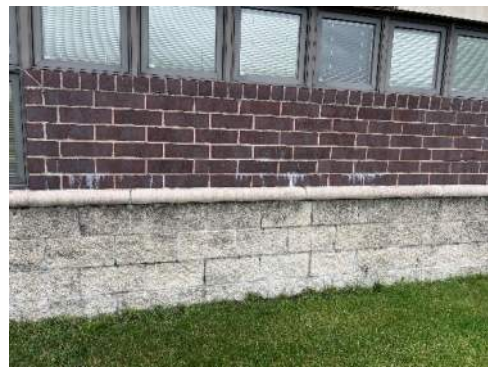
In general, the condition of the existing masonry around the facility is in good shape. In limited areas around the facility there is evidence of deterioration of mortar joints and sealed joints. The deterioration of mortar joints was observed on the lower concrete block portions of the wall, window sills, and concrete cornice and decorative elements. This type of deterioration is common for masonry buildings as they age. Because of its age, there is maintenance necessary to keep it in its current condition. Failure to minimize moisture penetrations into these joints will lead to rapid deterioration due to freeze-thaw cycles and further degradation of the masonry wall.

Recommendation: It is recommended that the mortar joints at these identified areas be tuckpointed. It is also recommended that all joints in the masonry wall be re-caulked. This would include masonry control joints, sealed joints, perimeter of windows and doors, and other similar joints.

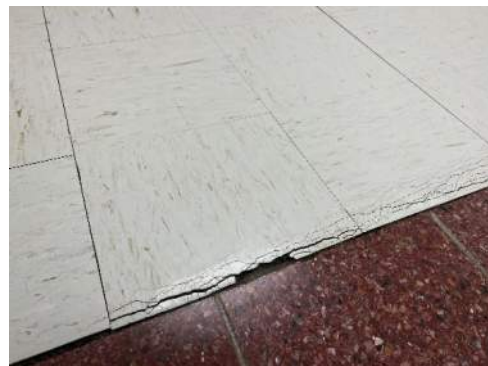
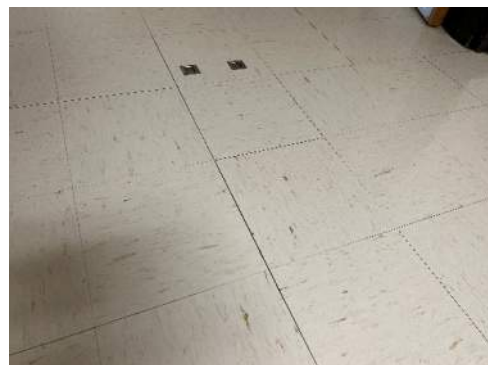
Flooring throughout the corridors of the facility and select rooms consists of vinyl composite tile (VCT) and rubber wall base that was installed as part of the original construction. In addition, there is a portion of VCT installed within the cafeteria area as well. Maintenance staff have been very diligent in the regular maintenance and waxing of the flooring to extend its useful life. Some installation areas now exceed 30 years. However, the annual routine waxing process has slowly worn away the wear surface of the VCT to wear the adhesive patterns of the backing are visible. In addition, normal shrinkage and movement of the building has caused some joints to widen and some tiles to crack.

Recommendation: Replace all VCT and wall base with an epoxy resin flooring. An epoxy resin flooring will provide a surface that is uniform and without joints. In addition, waxing of the surface is not necessary as the floor surface can be cleaned with water.

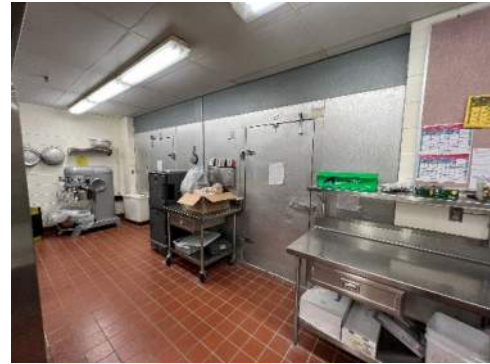
The existing cooler and freezers are original to the building. The level of maintenance necessary to keep them operational has been trending upwards. This creates the potential for a critical failure during operational periods where they may have to go down if replacement parts aren't readily available.

In addition, the existing ice maker is in need of replacement.

Recommendation: Replace both units with similar sized units. Provide new ice maker.

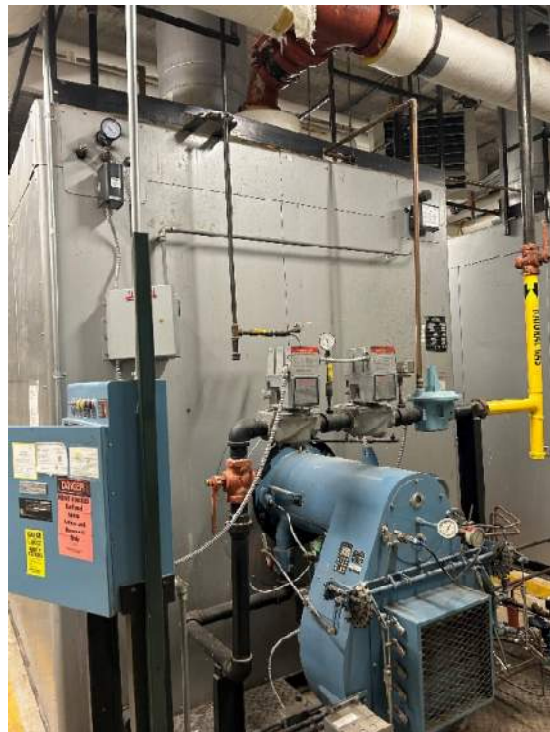
BOILER-1

MANUFACTURER	BRYAN
MODEL #	RW850-W-FDGO
SERIAL #	71317
CONDITION	Fair
RECOMMENDATION	Replace
REMARKS	Provide new near condensing and fully condensing boilers.

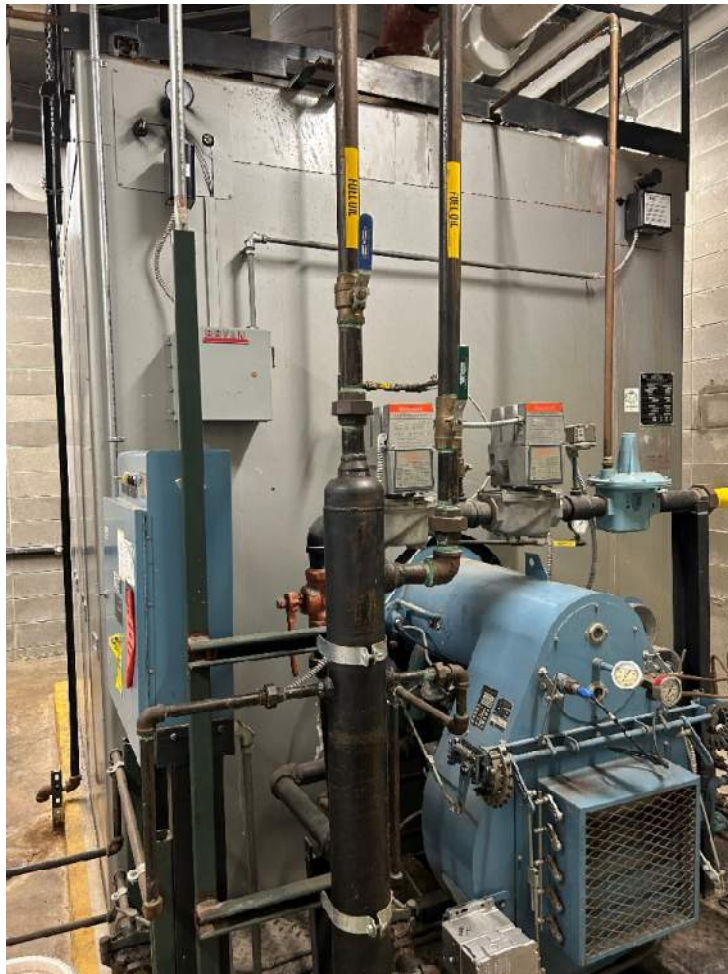
BOILER-2

MANUFACTURER	BRYAN
MODEL #	RW850-W-FDGO
SERIAL #	71316
CONDITION	Fair
RECOMMENDATION	Replace
REMARKS	Provide new near condensing and fully condensing boilers.

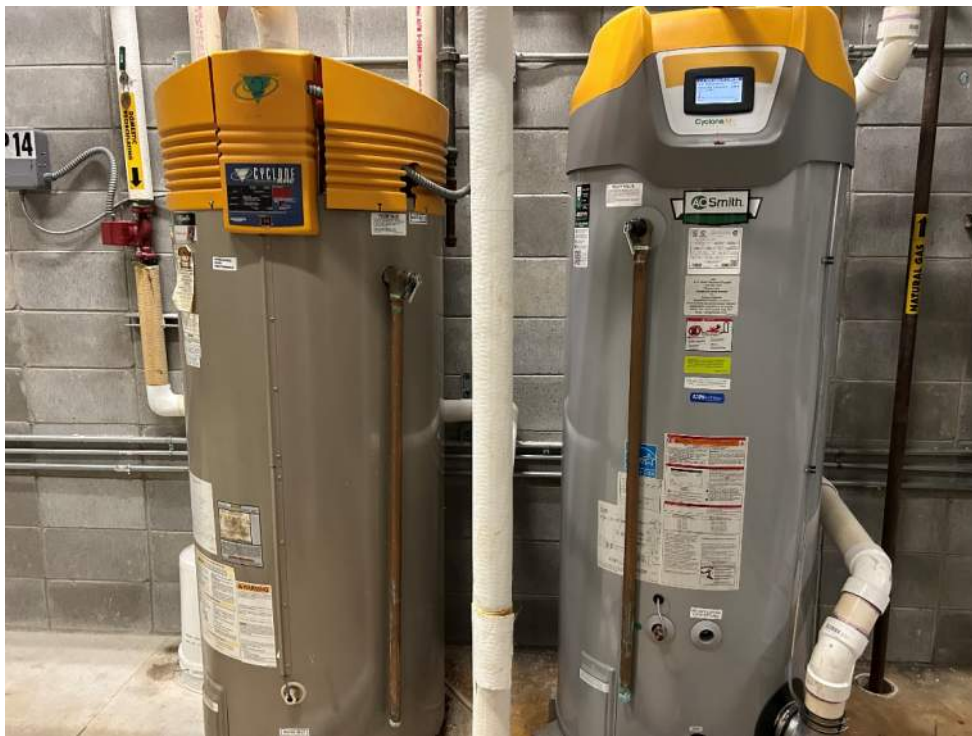
WH-1 (Water Heater 1)

MANUFACTURER	CYCLONE
MODEL #	BTH 250 966
SERIAL #	MC98-0726963-966
CONDITION	Poor
RECOMMENDATION	Replace
REMARKS	Currently unit is not operating.

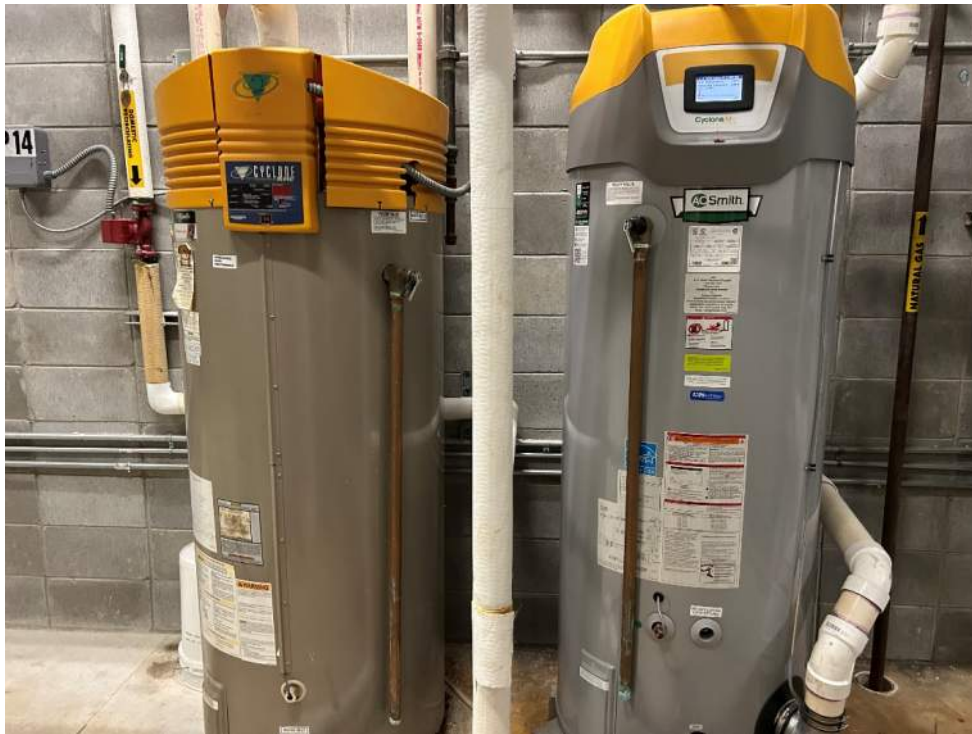
WH-2 (Water Heater 2)

MANUFACTURER	A.O. SMITH
MODEL #	BTH-250 300
SERIAL #	2029120113217
CONDITION	Good
RECOMMENDATION	Leave as is
REMARKS	Implement this heater into the new domestic water system.

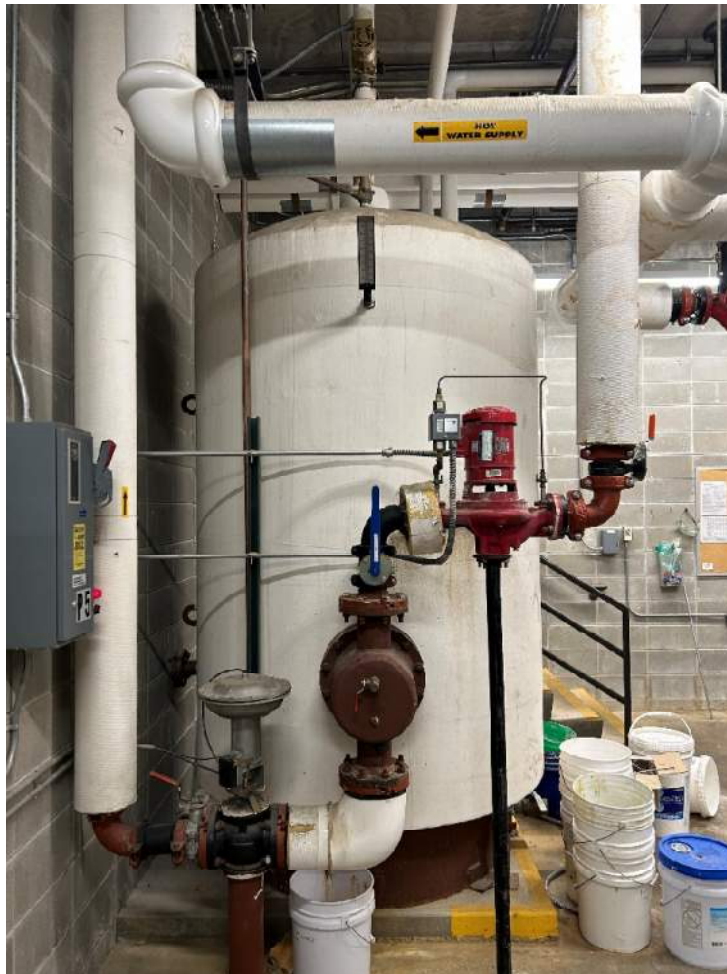
STORAGE TANK CIRCULATION PUMP

MANUFACTURER	BELL & GOSSETT
MODEL #	2X7 5.875 BF
SERIAL #	1708873
CONDITION	Fair
RECOMMENDATION	Replace
REMARKS	Replace with high efficiency water heaters.

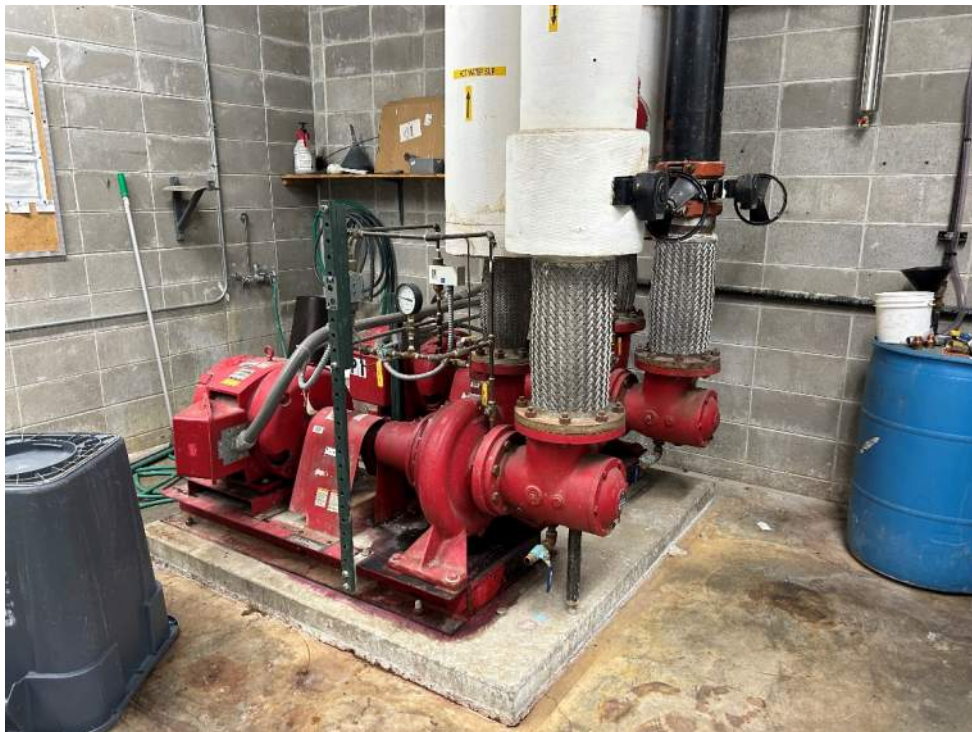
CP-1 & CP-2 (HOT WATER PUMPS)

MANUFACTURER	BELL & GOSSETT
MODEL #	XL5G 12.875 BF
SERIAL #	1699881
CONDITION	Fair
RECOMMENDATION	Replace
REMARKS	Provide new base mounted pumps to help match system load better.

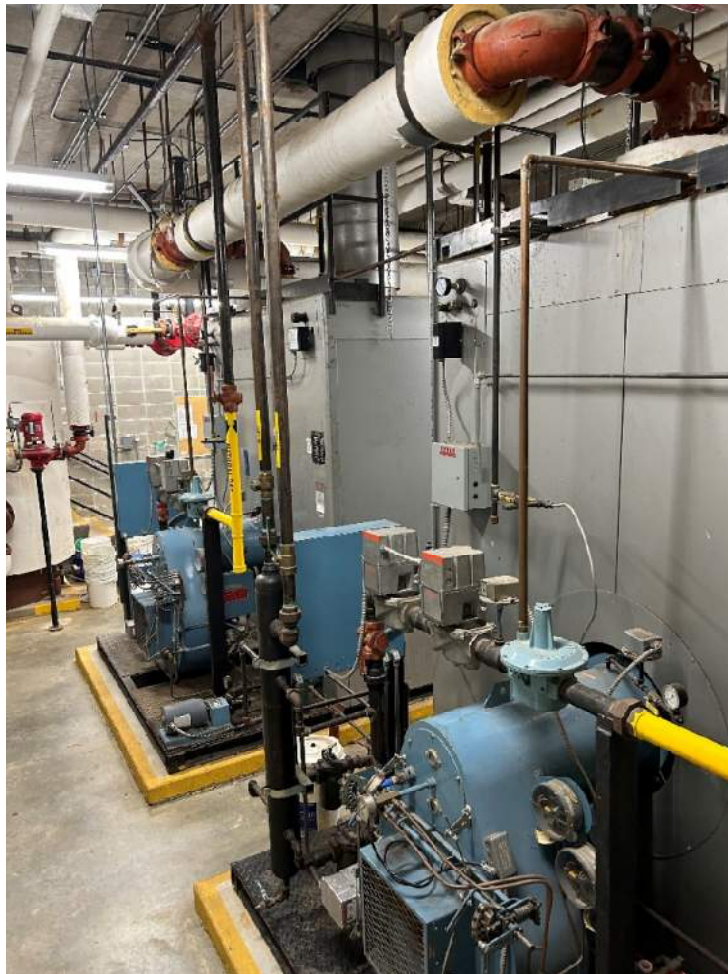
BOILER BURNERS

MANUFACTURER	GORDON-PIATT ENERGY GROUP
MODEL #	F14.9-GO-30
SERIAL #	UNKNOWN
CONDITION	Fair
RECOMMENDATION	Replace
REMARKS

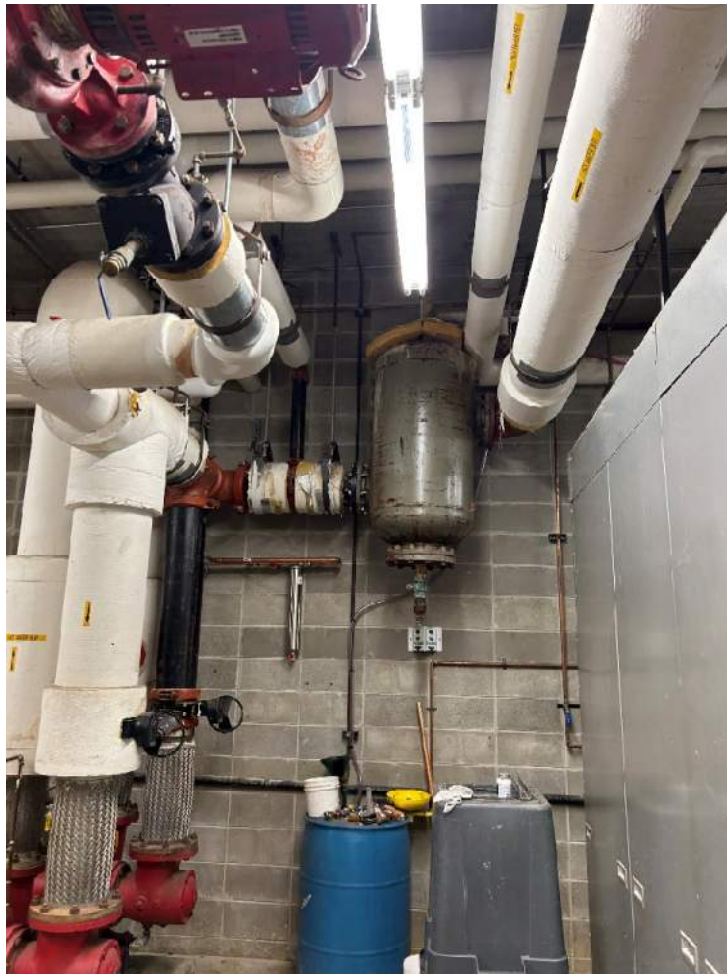
AIR SEPARATOR

MANUFACTURER	UNKNOWN
MODEL #	UNKNOWN
SERIAL #	UNKNOWN
CONDITION	Fair
RECOMMENDATION	Replace
REMARKS

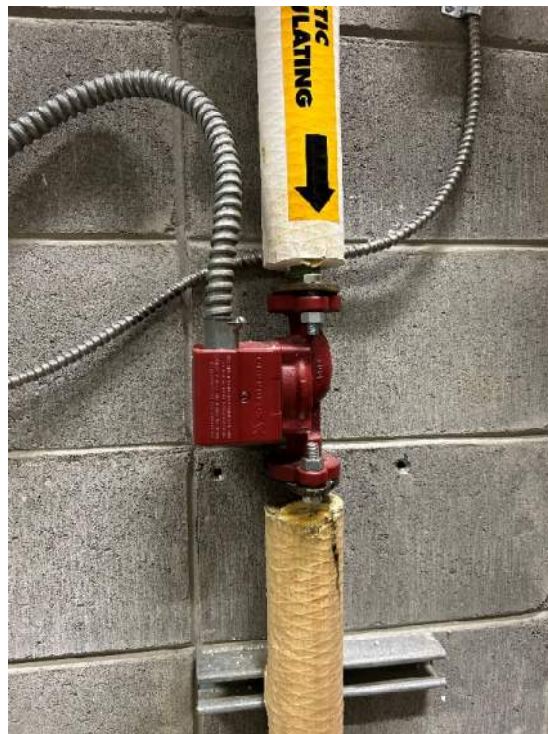
WATER HEATER CIRCULATION PUMP

MANUFACTURER	GRUNDFOS
MODEL #	UNKNOWN
SERIAL #	UNKNOWN
CONDITION	Good
RECOMMENDATION	Replace
REMARKS	Need to review size and flow – unit appears to be smaller than required.

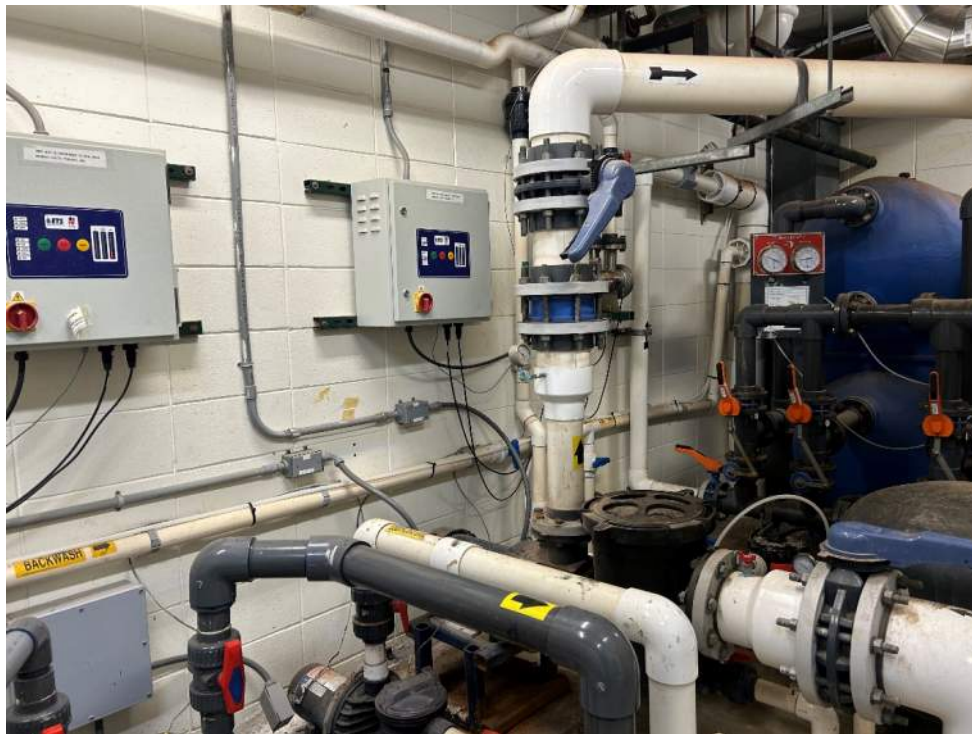
POOL CIRCULATION PUMP

Within the pool mechanical room are several pumps operating the pool. The main pool circulation pump sits within the room and is a base mounted unit. The pump runs at full speed constant volume all the time.

MANUFACTURER	PENTAIR
MODEL #	EQKT1500
SERIAL #	UNKNOWN
CONDITION	Good
RECOMMENDATION	Leave as-is
REMARKS	Provide unit with VFD to match load required.

Recommendation: Provide the pump with a variable frequency drive so that the system can be better operated to match the load needed for the pool system. VFD should be interlocked with the DDC control system so the unit is able to be monitored from the front end at the operator workstation.
