FACILITY ASSESSMENT
LAKE OF THE WOODS SCHOOL
BAUDETTE, MINNESOTA

NOVEMBER 2023

WIDSETH

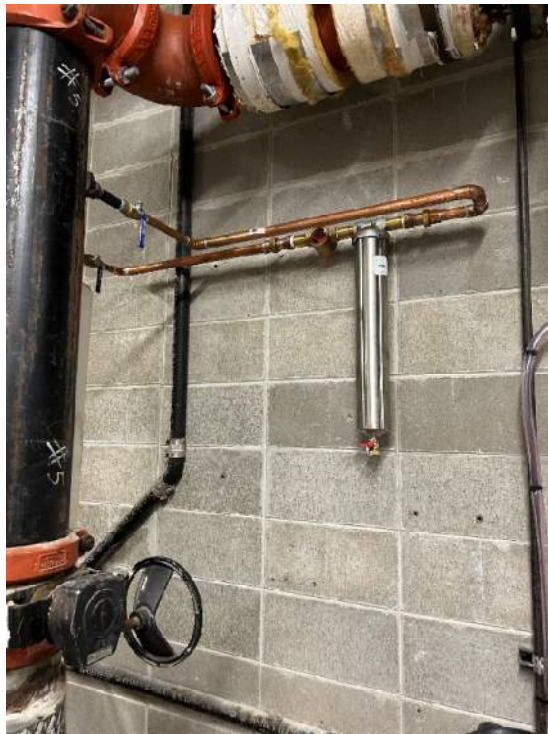
LOCATION: A127: BOILER ROOM

MANUFACTURER	UNKNOWN
MODEL #	UNKNOWN
SERIAL #	UNKNOWN
CONDITION	Good
RECOMMENDATION	Leave as is
REMARKS

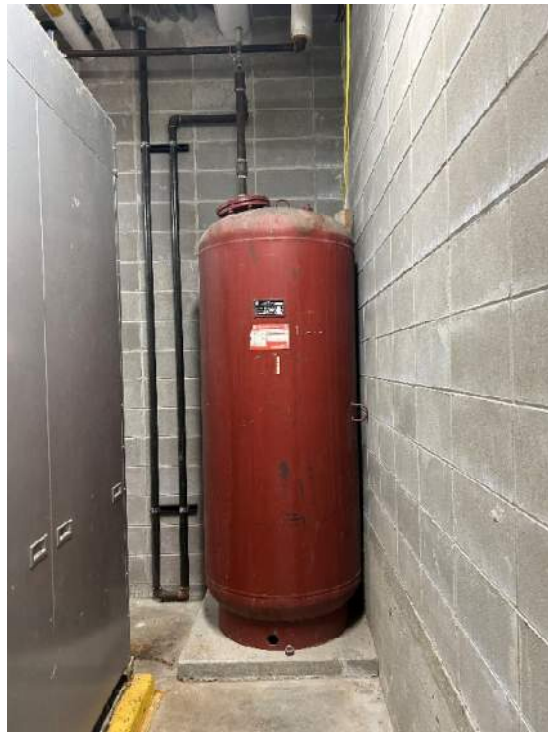
EXPANSION TANK

LOCATION: A127: BOILER ROOM

MANUFACTURER	BELL & GOSSETT
MODEL #	UNKNOWN
SERIAL #	91-1941
CONDITION	Good
RECOMMENDATION	Leave as is
REMARKS
